**CONSOLIDATION AND ADHESIVE REPAIR OF VOLCANIC TUFF  
CASE STUDY: CONSERVATION OF VOLCANIC TUFF AT THE OLD  
STONE CHURCH OF MISSION SAN JUAN CAPISTRANO,  
SAN JUAN CAPISTRANO, CALIFORNIA**

Evin Hewett Erder

A THESIS

The Graduate Program in Historic Preservation

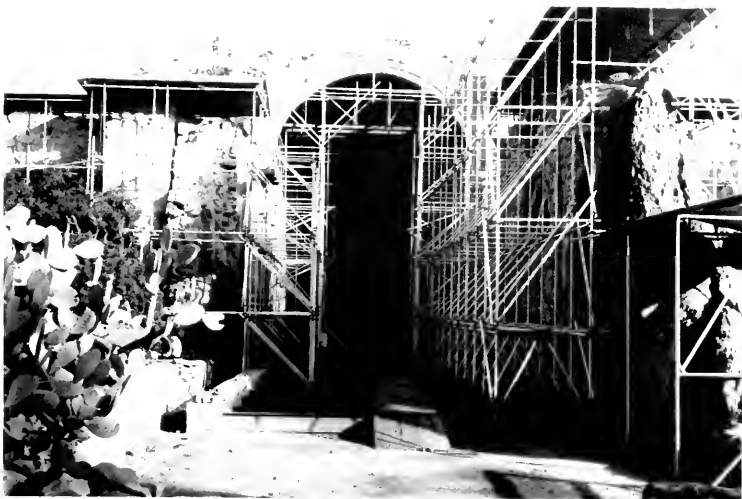
Fig. 2. View of nave of Old Stone Church, Mission San Juan Capistrano (1994).

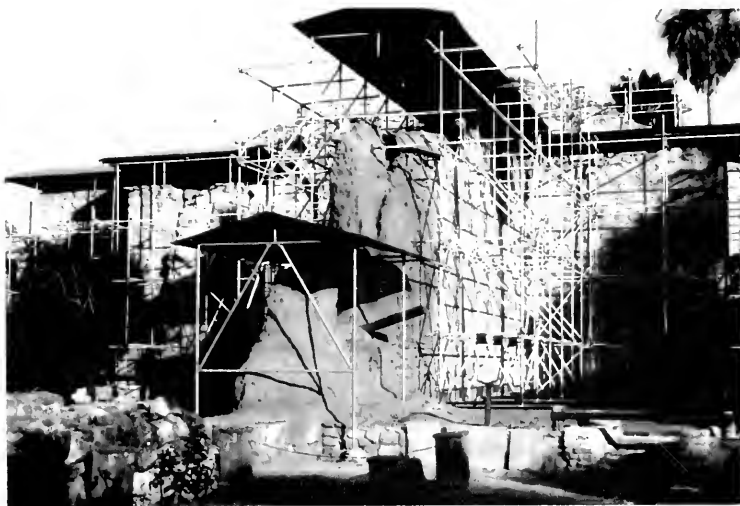
Fig. 3. View of exterior wall of nave and east transept of Old Stone Church (1994).

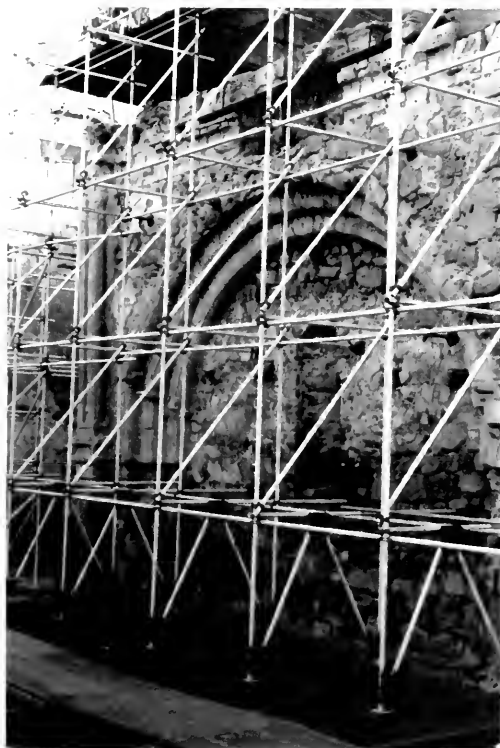
Fig. 4. View of east wall of nave, Old Stone Church (1994). The load-bearing stones are green and yellow sandstone. The stones in the cornice and pilaster are volcanic tuff, and the stones in the arch yellow sandstone and tuff. Fragments of lime-based plaster are present below the cornice and arch.

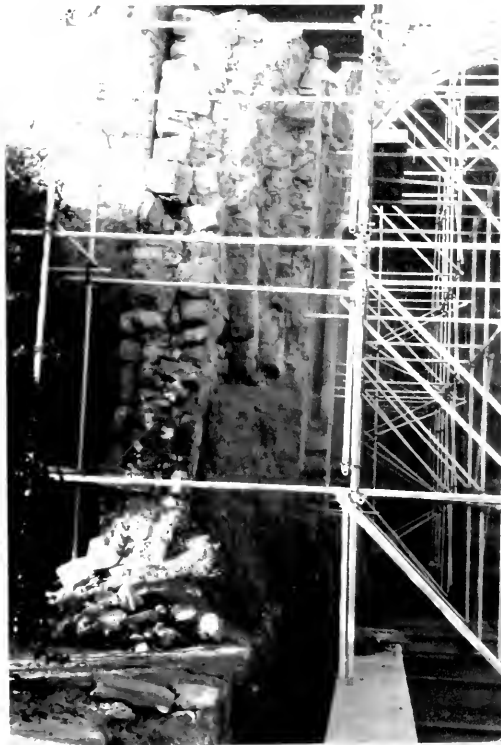
Fig. 5. West wall of nave, Old Stone Church (1994). The load bearing stones are yellow and green sandstone. The core of the wall consists of rubble stone, brick, and lime-based mortar.

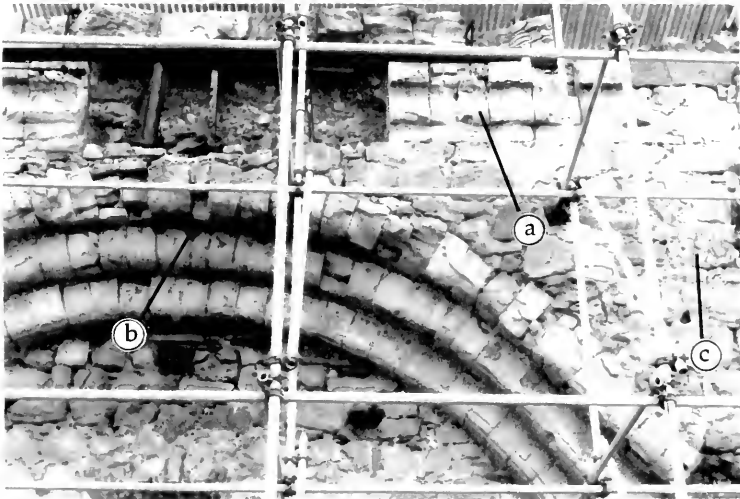
Fig. 16. East wall of nave. Stones in the cornice are volcanic tuff (a) and the stones in the arch are tuff and yellow sandstone (b); the load-bearing stones are yellow and green sandstone (c).

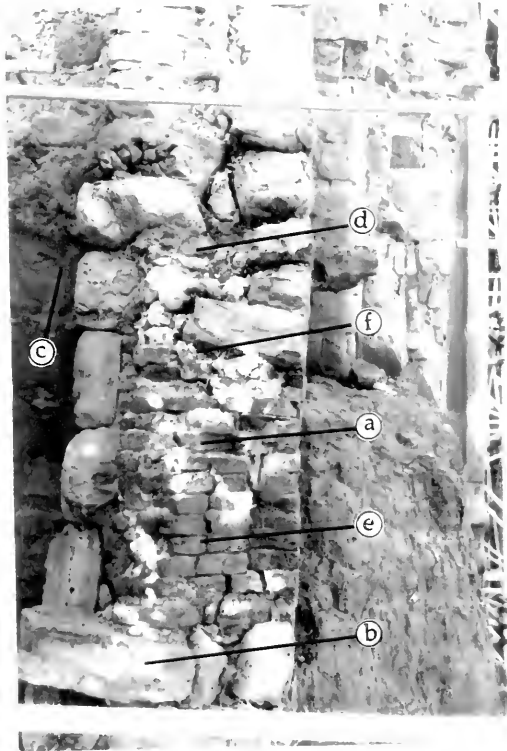
Fig. 17. Cross-section of west wall of nave. The outer and inner face of the wall consists of brick (a), yellow (b) and green sandstone(c), and the core of the wall of rubble stone (d), brick (e) and lime based mortar (f).
